Manhole Inspection Summary

Manhole # S43SS_015MH

Insp Date: **2/22/07 1:48 PM**

Location Address: **1605 HOMESTEAD ST**

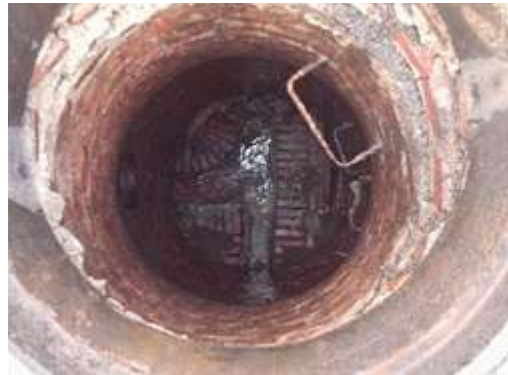
Top View

Corbel infiltration. Corroded and missing steps. Bench and Channel debris.

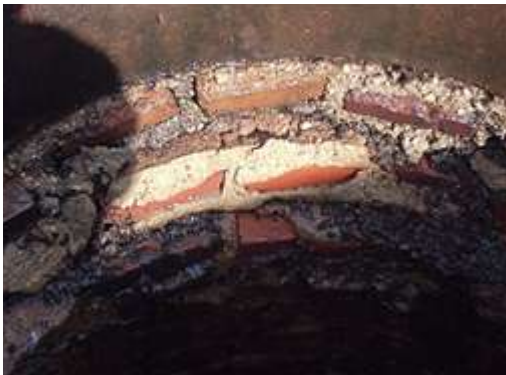
Defect

Frame leaks. Adjustment deterioration and infiltration.

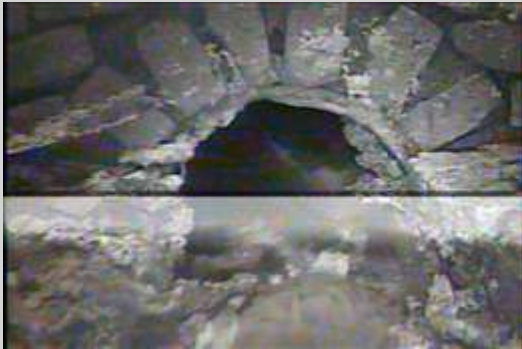
10 in. Circular Gravity Sewer Pipe Out @ 12 O'Clock

Deposits: ☐ None ☒ **Mud** ☐ Sludge ☒ **Debris** ☒ **Grease**

Silt Depth: **2** (in.) Deposits Extent: **Medium**

Infiltration: **None** Pipe Seal Cond: **Broken**

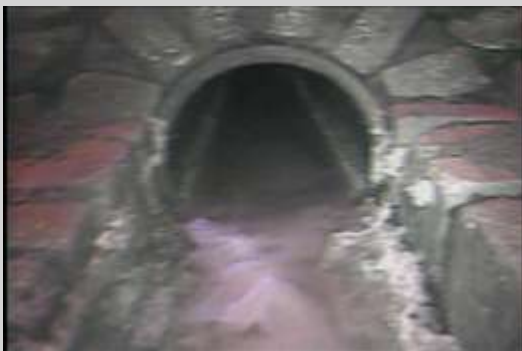
8 in. Circular Gravity Sewer Pipe In @ 6 O'Clock

Deposits: ☐ None ☒ **Mud** ☐ Sludge ☒ **Debris** ☒ **Grease**

Silt Depth: **1** (in.) Deposits Extent: **Light**

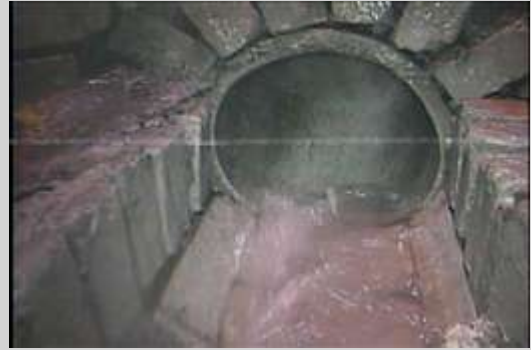
Drop In @ 9 O'Clock

Channel deterioration.
